Appendix C – Well Video Inspection Reports

Well Inspection Report

WELL NUMBER: Well 147 **General inspection** **JOB NUMBER:** 49818

WELL NUMBER: Well 145 **General inspection** **JOB NUMBER:** 49818
SURVEYED BY: Jose Rocha **DATE:** 17-May-18
REVIEWED BY: **WATER LEVEL:** 157.4'
WATER CONDITION: Clear **TOTAL DEPTH:** Unknown
CASING DIAMETER: 20" ID **SURVEY DEPTH:** 1154'

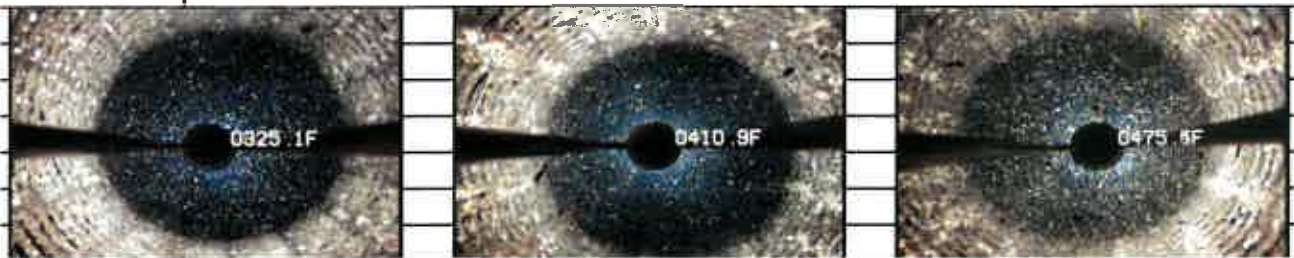
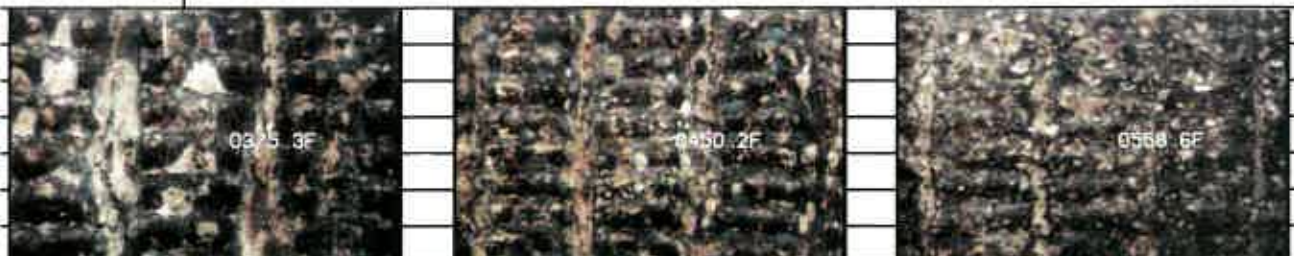
DEPTH	REMARKS		
0 - 114'	Casing appears to have mild scale and growth.	Perforations:	
114 - 245'	Casing appears to have mild to moderate scale and growth.		
245 - 321'	Casing appears to have moderate to heavy scale and growth.	Ful / Flo Louver	321 - 390'
321 - 598'	Casing appears to have heavy scale and growth.		410 - 465'
598.7'	Camera comes to rest on top of fill.		475 - 580'
303.2' - 305.1'	It appears to be a sounding port.		
308 - 315.1'	It appears to be a camera port.

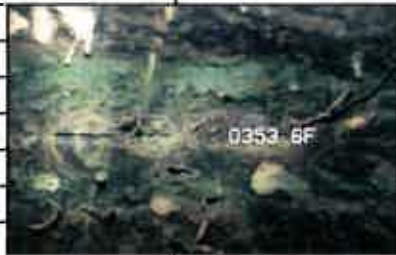
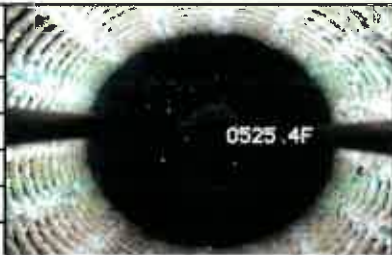
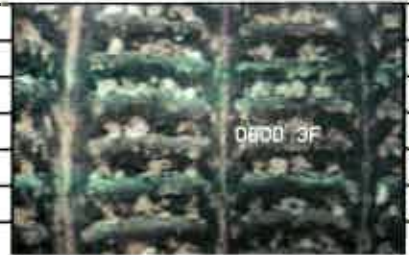
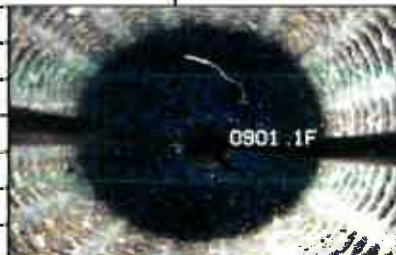
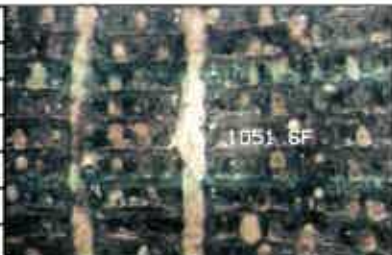
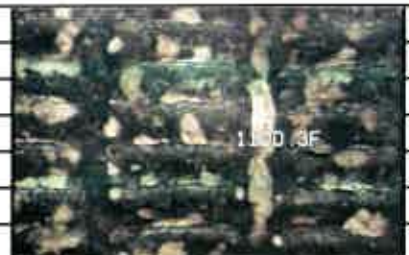
DEPTH	REMARKS		
0 - 140'	Casing appears to have mild scale and growth.	Perforations:	
140 - 225'	Casing appears to have mild to moderate scale and growth.		
225 - 350'	Casing appears to have moderate scale and growth.	Ful / Flo Louver	375 - 423'
350 - 1154'	Casing appears to have heavy scale and growth.		443 - 539'
1154'	Camera comes to rest on top of fill.		554 - 569'
355.6' - 356.6'	It appears to be a sounding port.		789 - 804'
361.6' - 368.6'	It appears to be a camera port.		819 - 995'
353.6'	Water flowing out of casing joint.		1010 - 1070'
			1080 - 1135'
